FARMINGTON RIVER BASIN
HARWINTON, CONNECTICUT

**BRISTOL RESERVOIR NO.4 DAM
CT 00364**

**PHASE I INSPECTION REPORT
NATIONAL DAM INSPECTION PROGRAM**

JUNE 1981

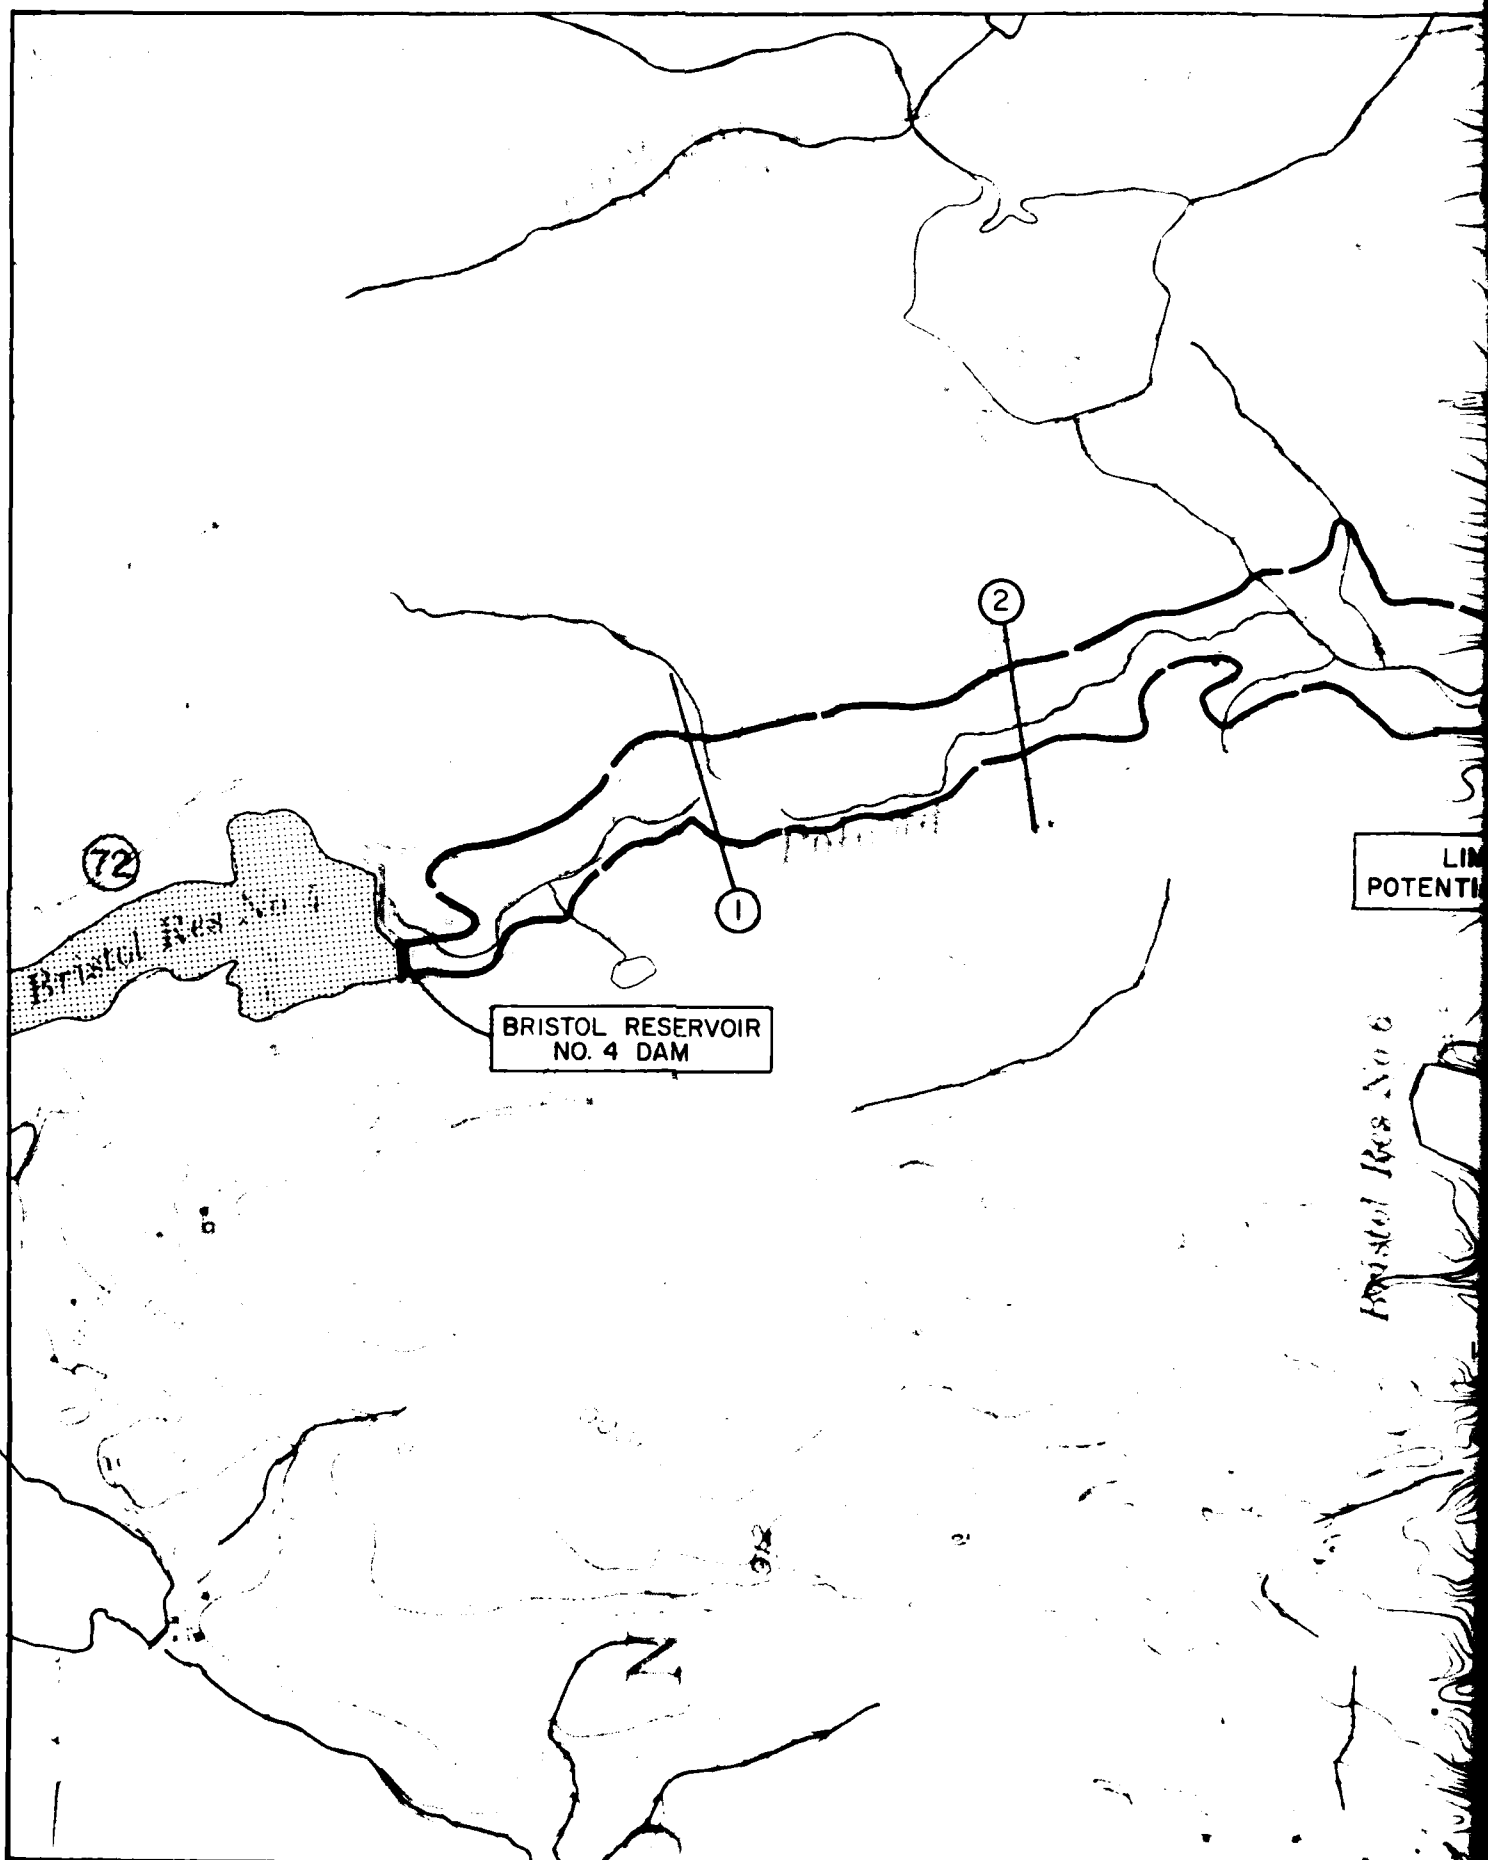
FIGURE 5

The flood wave would produce depths of 10 to 18 feet in the Poland River overtopping Connecticut Route 72 for a distance of about 2 miles by depths of up to 5 feet. Further downstream, the flood would overtop Route 72 at several locations, Preston Road and the dam at Bristol Reservoir No. 3 (incorrectly labeled Bristol Res. No. 2 on the U.S.G.S. Quadrangle Sheet). The flood flow at a factory complex located 3 miles below the dam would have a depth of about 7 feet, and would inundate the lower portions of the factory to a depth of about 1 foot. The factory complex is operated by O-Z/Gedney and consists of several interconnected buildings. See Figures 5 and 5A, pages D-47 and D-48 in Appendix D.
